**Restoration Plan  
for  
Trib. 414 Watershed  
Chester County, Pennsylvania  
August 2008**

RETTEW Associates, Inc.  
Natural Sciences Group  
950 East Main Street, Suite 220  
Schuylkill Haven, PA 17972  
(570) 385-2270  
(570) 385-2217 fax  
RETTEW Project No. 07-07957-002

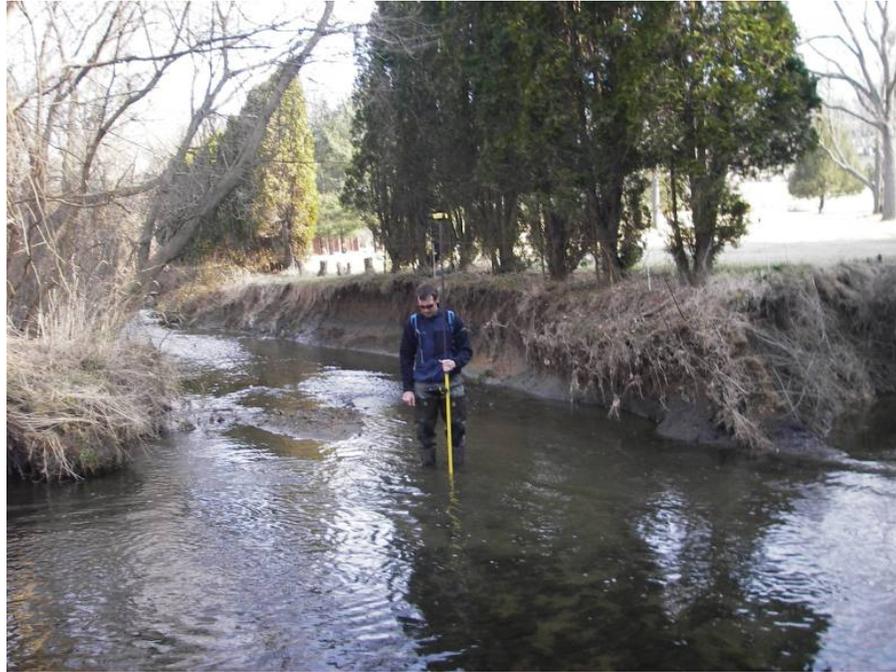
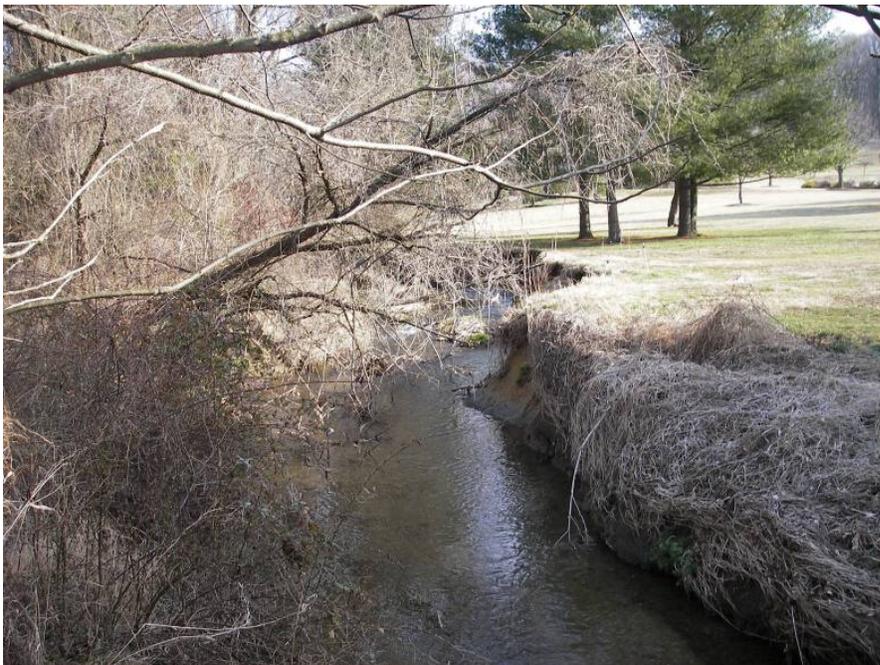
#### Impacted Stream Segment #1-4:

At the confluence of Trib. 414 and the East Branch of Red Clay Creek looking upstream on Trib. 414, a riparian forested buffer is lacking on the east side of the stream. The lawn area adjacent to the stream is mowed to the top of a 3-5' high eroded bank from points 1 through 4. Approximately 50 feet upstream of point #1, a 50 foot section of streambank was lined with broken concrete rip-rap. The stream has eroded behind the rip-rap area. The west side of the stream has a wide stream buffer. The plant community contains some invasive multi-flora rose.

This section of stream requires streambank stabilization from a fluvial geomorphology (natural stream design) approach. The invasive multi-flora rose should be eradicated before a forested riparian buffer is planted with native tree and shrub species.

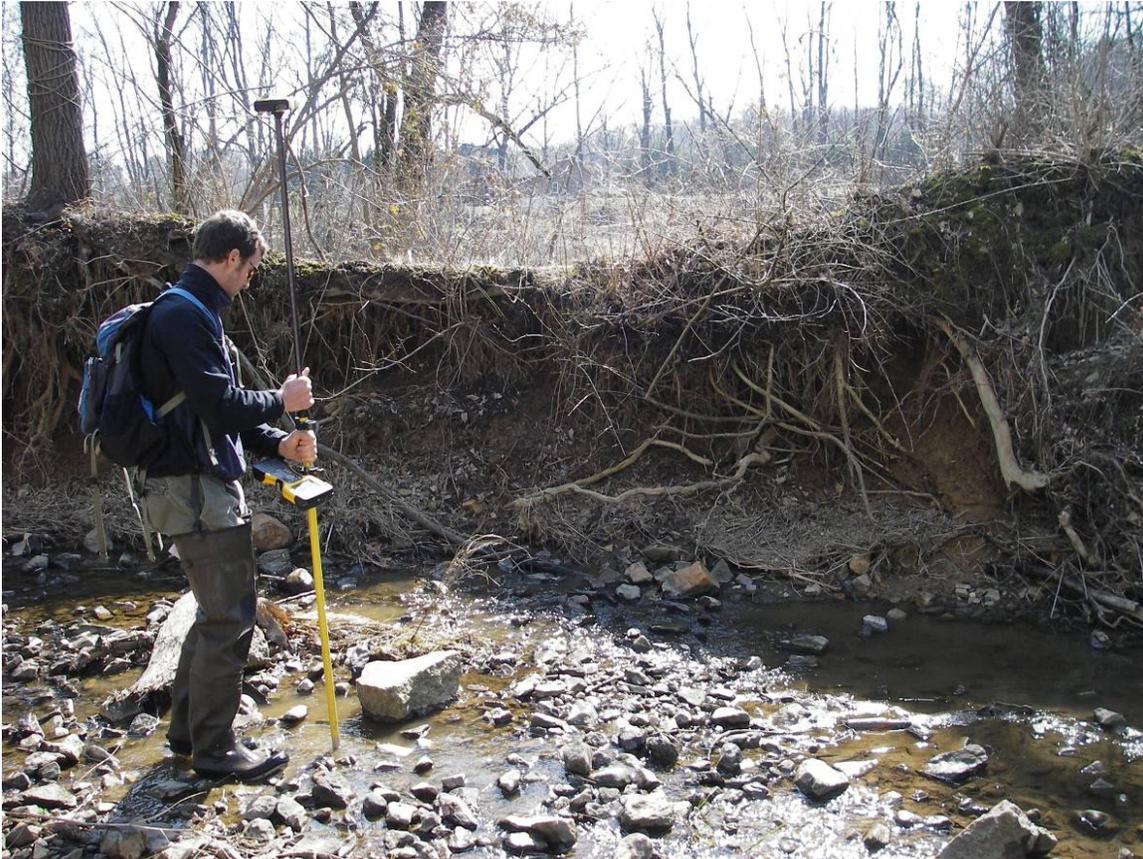
### **Impacted Stream Segment #15:**

This section of Trib. 414 has evidence of the stream being relocated to its present location. It appears that Trib. 414 was diverted around the large off-line dam. At this location, the stream is attempting to reach a stable state and has eroded its streambank and is close to cutting through and spilling into the large off-line pond east of the stream. If the stream is able to cut through the bank at this location, approximately 600 feet of stream will go dry. Upstream of this location, the landowner is clearing the bank of vegetation.

While the long-term stability of this section of the stream would include a major restoration effort to return the stream to its historic location, a much more practical approach is to stabilize the bank in the areas of erosion. Stabilization of this area should be coupled with landowner education, native riparian buffer plantings in the cleared area, and the inclusion of in-stream structures for fish habitat enhancement.

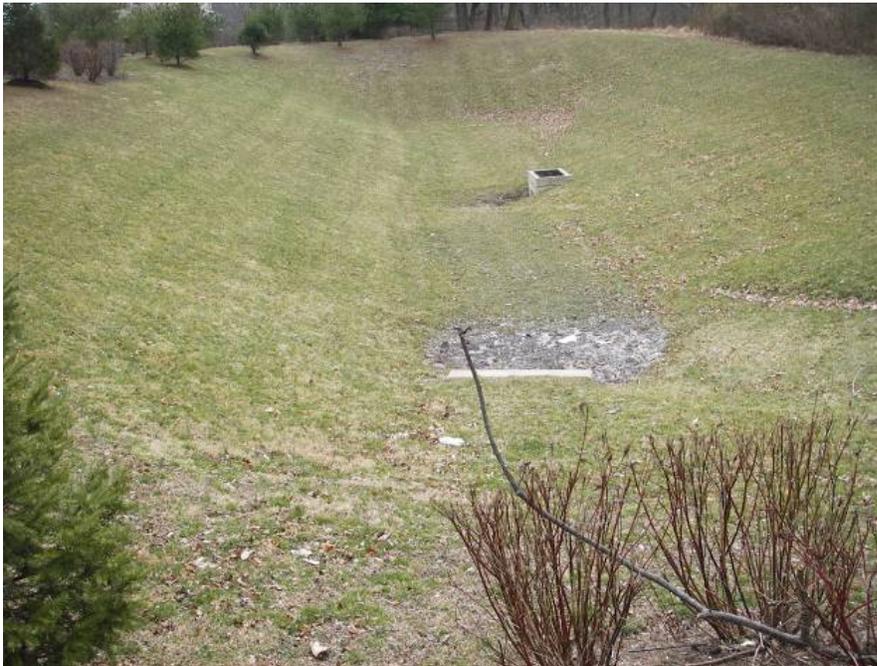
**Impacted Stream Segments #39-Headwaters and #73-Headwaters:**

The stormwater from the extensive impervious areas upstream of this location are likely the cause of much of the downslope degradation. While the stream is not incised and indicative of an impacted stream from a habitat standpoint, the shallow bedrock is likely playing a role in stabilizing this area. While points 39 and 73 indicate the areas of the watershed where stormwater management retrofits become most necessary, this high priority project is a watershed wide initiative. The field investigation map indicates where good sites for initial stormwater best management practice retrofit projects are located (Appendix A).

Urban stormwater management retrofits that consider volume, rate, and water quality should be included with any work that drains into Trib. 414. While landowner education targeting homeowners will be helpful, an outreach program that targets the commercial areas of the watershed may have the greatest potential for success. Consideration should be given to development of a recognition program

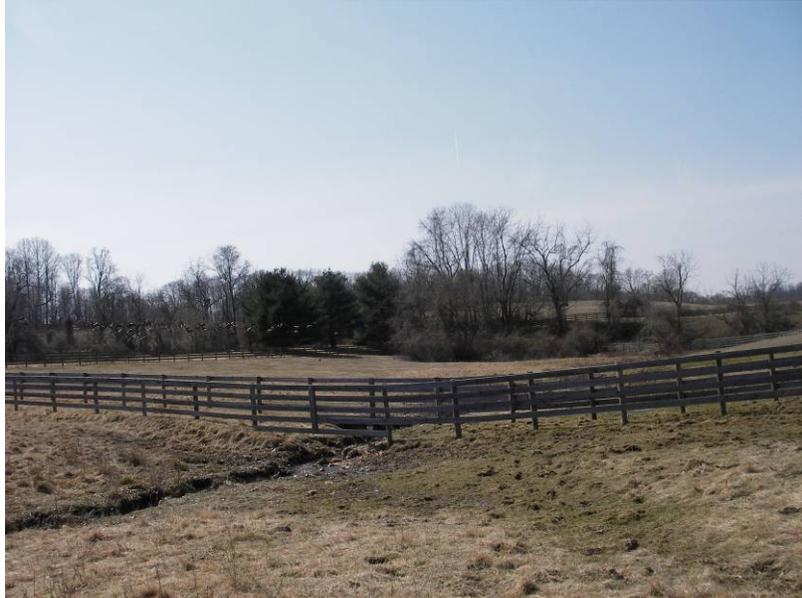
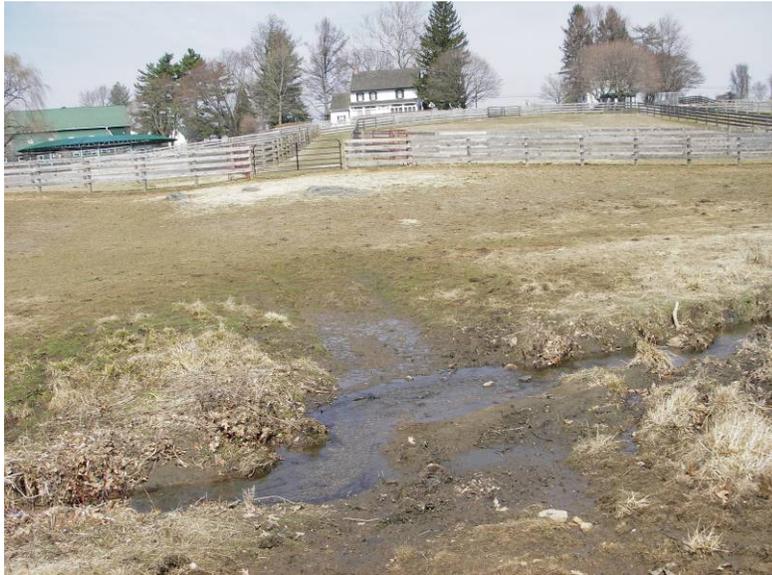
**Impacted Stream Segment #57-58:**

This section of the stream includes a large well maintained ranch where livestock graze in several large pastures. An unnamed tributary to Trib. 414 flows through the center of the pastures and is freely accessible to livestock in the pastures. The streambanks in the upper section of this area are eroded up to three feet deep on the outside of meander bends.

While a limited amount of streambank stabilization would be beneficial, the primary focus of restoration of this tributary should be on streambank fencing and establishing a riparian buffer. Fencing livestock out of the riparian corridor would allow for a forested riparian buffer to be installed. In areas where livestock need to cross the stream routinely, livestock crossings should be installed.

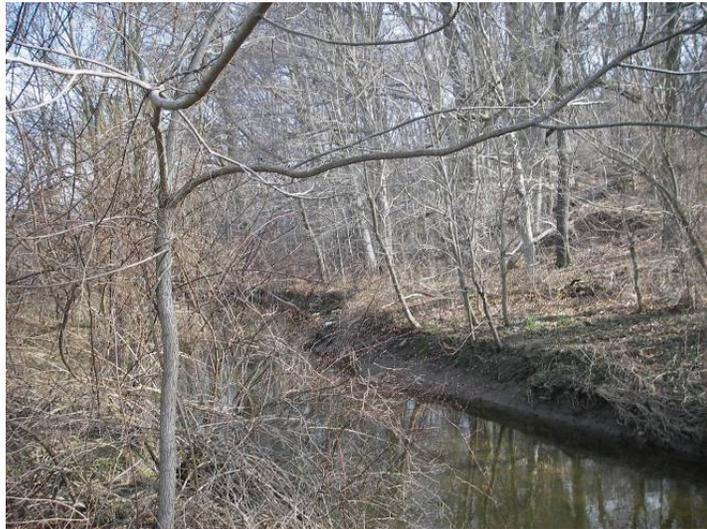
#### **Impacted Stream Segment #4-5:**

Upstream of this point, the eastern side of the stream is comprised of mature forest with 2-3 feet high eroded banks. The west side of the stream has 4-5 feet high eroded banks along this entire section. Multiflora rose is common in the open meadow/emergent wetland floodplain plant community located east of the stream.

Streambank stabilization in this area that incorporates traditional streambank stabilization and natural stream design should be considered for this area. The wetlands and mature forest that surround this stream segment will add to the challenge of designing and permitting an effective natural stream design. The invasive multiflora rose should be eradicated from the project area.

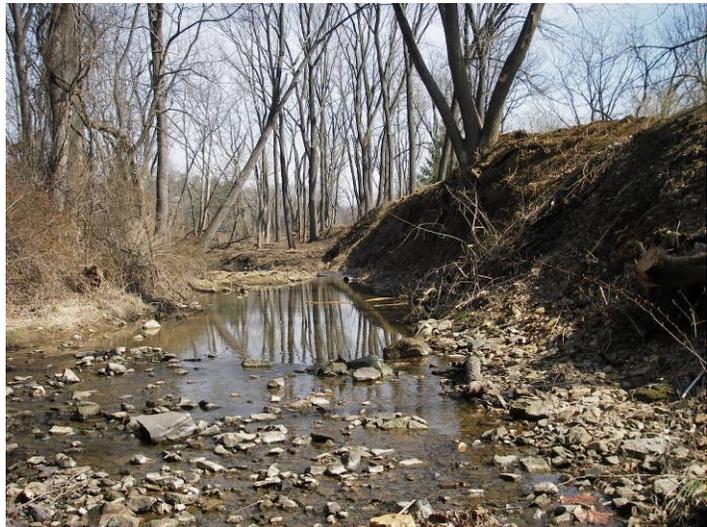
#### **Impacted Stream Segment #17:**

The streambank in this area is freshly cleared and grubbed to the stream edge without erosion control best management practices.

Install erosion and sedimentation controls according to Chester County Conservation District recommendations. A riparian buffer enhancement project that includes vegetating the streambank with native trees and shrubs should be considered.

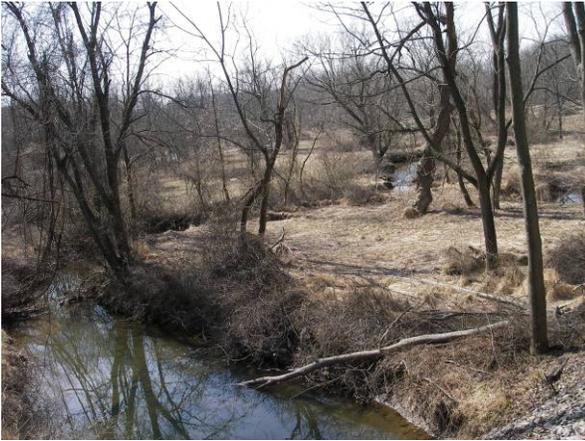
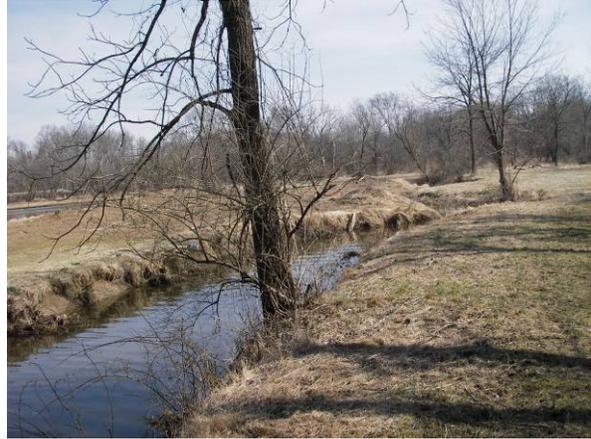
**Impacted Stream Segment #19-23:**

From points 19 through 23, the riparian zone is mowed to the top of both streambanks.

Riparian buffer enhancements in this area including native tree and shrub plantings to shade the stream would be a great benefit.

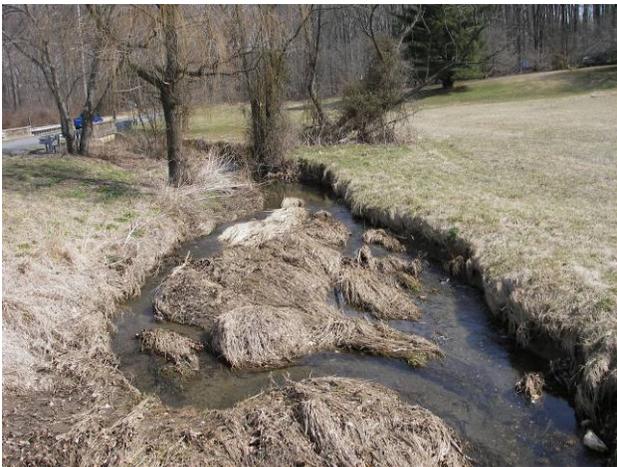
**Impacted Stream Segment #25-28:**

The streambanks throughout the majority of the stream segment from points 25 through 28 are incised approximately 3-4 feet deep. The upper end of this stream segment flows through a fallow field that is mowed to the top of the streambanks. While the lower section of the stream segment flows through a riparian buffer, invasive multiflora rose is dominant.

Streambank stabilization utilizing traditional and natural stream design techniques. Invasive species removal should be completed throughout the entire stream segment area so that a native forested riparian stream buffer may be established.

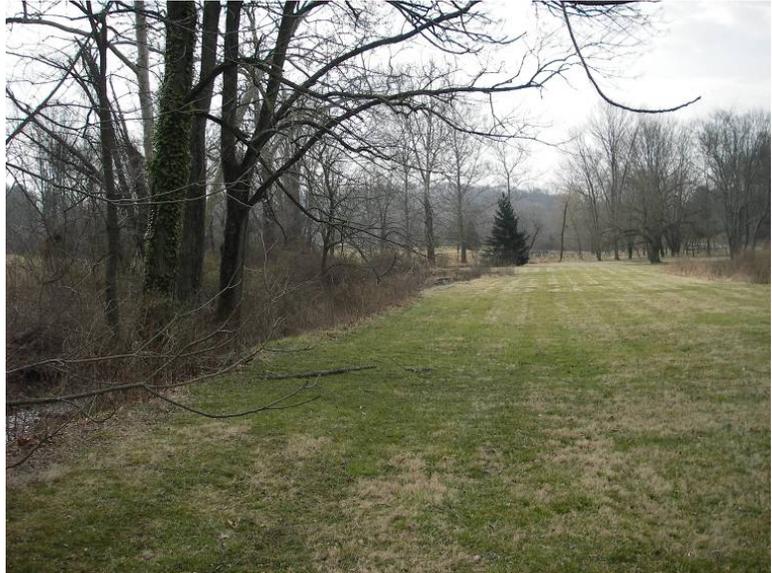
**Impacted Stream Segment #34-36:**

The stream segment from points 34 through 36 includes a small (approximately 5 feet wide) stream buffer that is bordered by mowed lawn. The lawn area is relatively flat and just slightly above the grade of the stream. A depression east of the stream may be the remnants of a historic off-line ice dam. A small area of erosion around tile drains is present with approximately 2 feet high eroded streambanks in the downstream end of the stream segment. Further downstream is an area that recently has been planted with trees to create a forested riparian buffer.

This section of stream may be an excellent location for the installation of a large floodplain bench wetland area that would help attenuate the effects of upstream stormwater discharges. Another less costly option to improve this stream section would be to install a forested riparian buffer throughout this section. Streambank stabilization in this area would be limited to traditional bank stabilization in the downstream section of the stream segment.

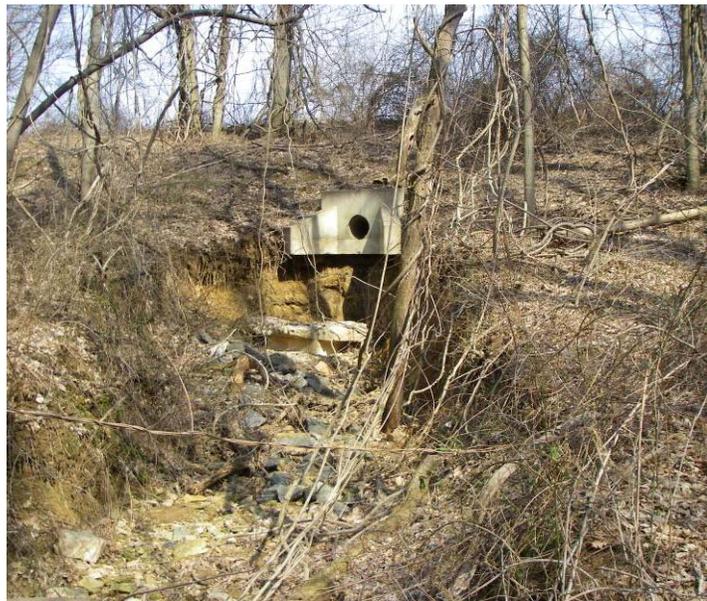
**Impacted Stream Segment #75:**

A stormwater outfall at this location is severely eroded from scour under the endwall.

Maintain outfall by installing an energy dissipating device (likely rip-rap) and designing a stable channel (likely a step pool design). This area should be assessed for the installation of stormwater management retrofits.
