# Upper East Branch Red Clay Creek Watershed Restoration Plan

East Marlborough and Kennett Townships  
Chester County, Pennsylvania

November 2010

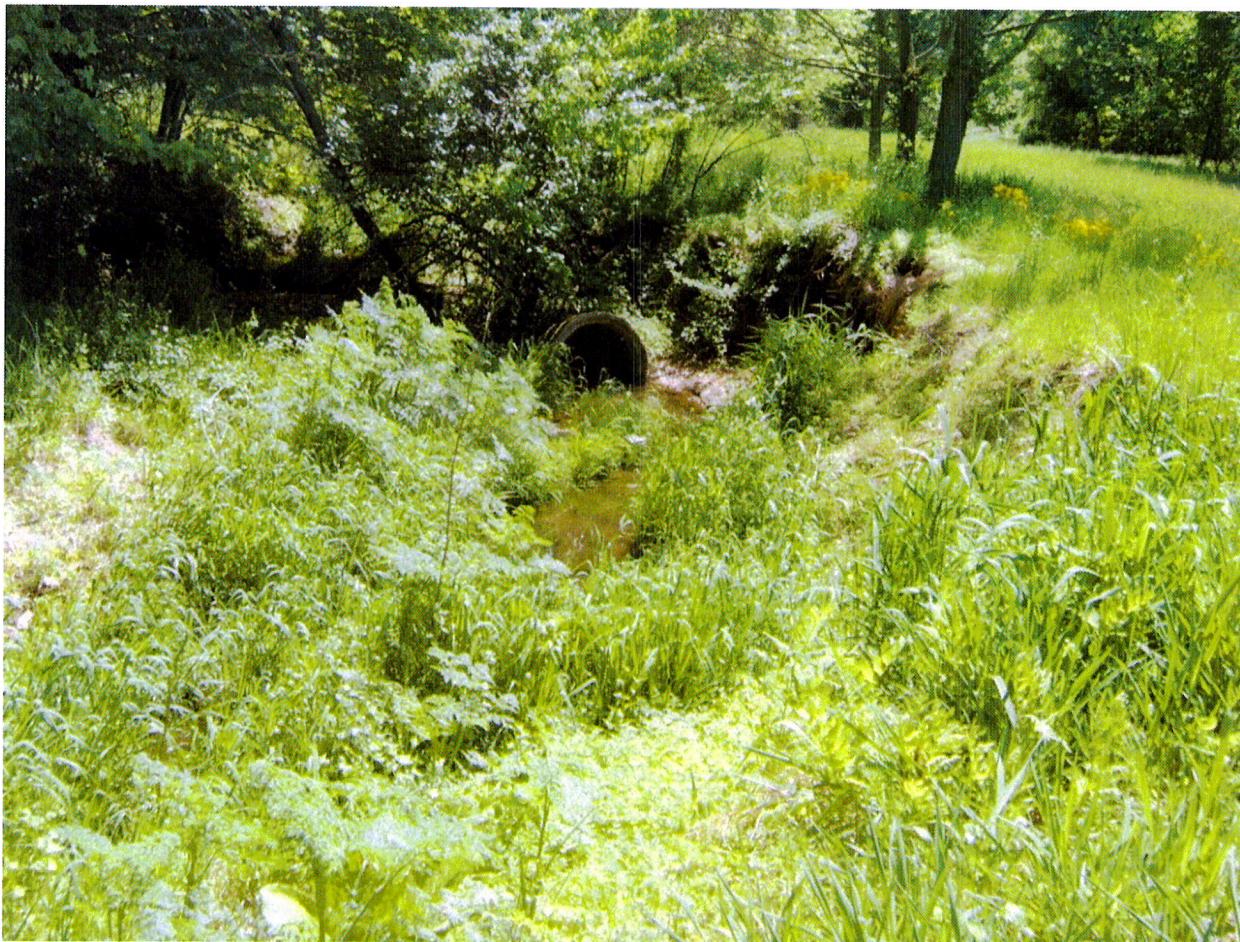
#### **Impacted Stream Segment #1-3:**

This stream segment is located in the headwaters of the mainstem of the Upper East Branch Red Clay Creek. Stormwater inputs and past agricultural sedimentation have contributed to a stream channel that is incised approximately 3 to 4 feet. The streambanks are eroding, but in some areas are healed over with herbaceous vegetation.

While streambank stabilization could provide a quick fix in this location, restoration of this area should include reconnecting the stream with its floodplain and installing a forested riparian buffer to the west of the stream. Reconnection of the floodplain in this area should help to reduce the impacts of stormwater within the forested area down slope. As the area immediately adjacent to the stream is currently open space, it may be possible to place soil removed from the floodplain on-site.

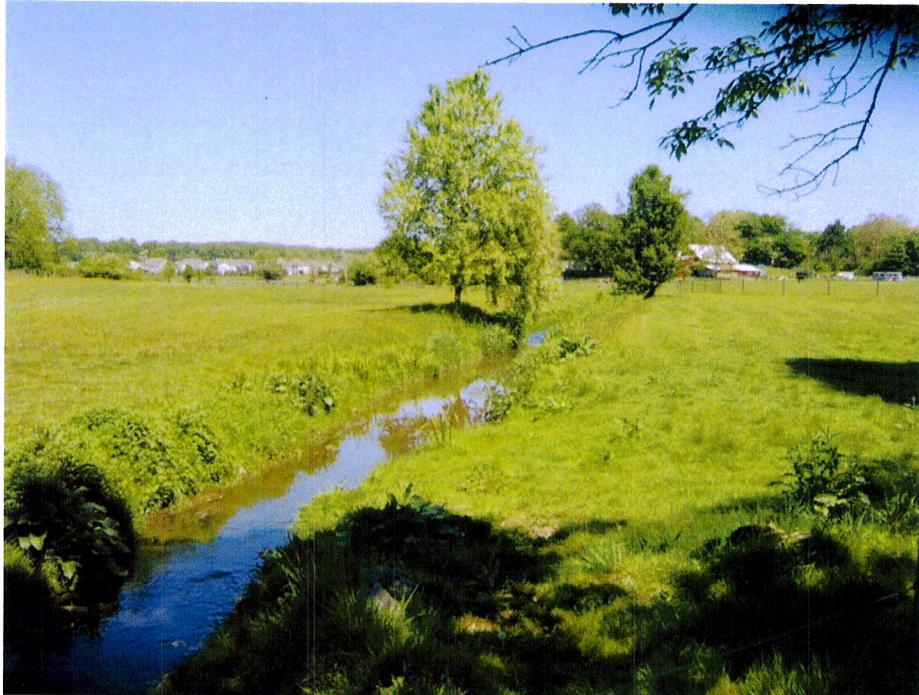
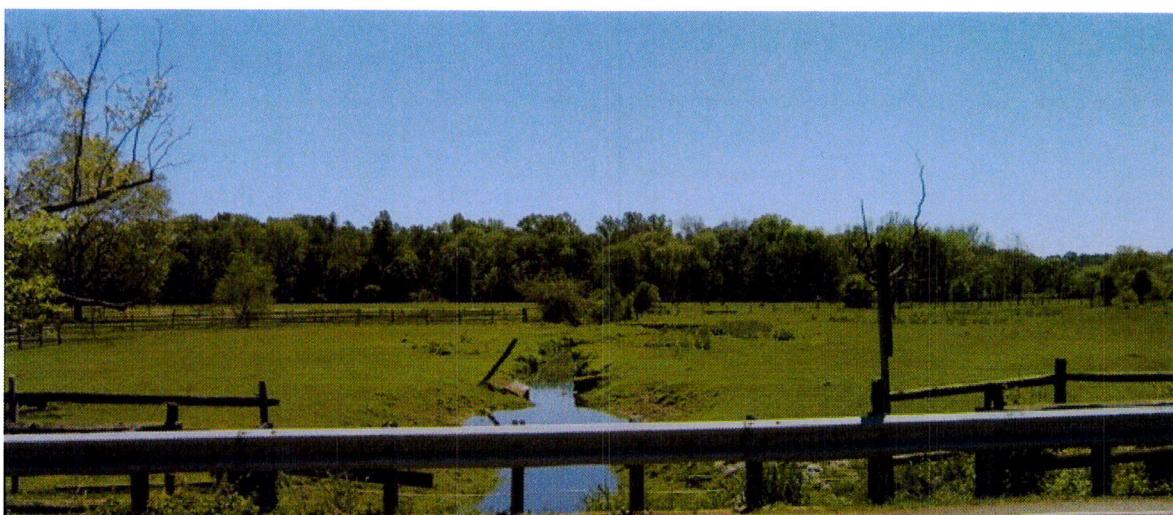
### **Impacted Stream Segment #8-9:**

Within this stream segment, livestock have direct access to the stream. While the streambanks are stable, the stream is exposed to direct sunlight throughout most of this section. The combination of nutrient inputs from livestock within and adjacent to the stream and full sun exposure likely contributes to algal blooms. Corresponding algal population crashes contribute to the impaired nature of stream assesment site 4 (Clauser and Clauser 2010).

Restoration of this area should primarily focus on getting the livestock out of the stream. Limiting livestock access to the stream will decrease nutrient inputs, sediment discharges, and pathogen levels within the stream. A combination of streambank fencing, stabilized stream crossing areas, and upland watering structures will be required to improve the water quality throughout this reach. Within the fenced buffer areas, native trees and shrubs should be planted to aid in shading the stream and mitigating water temperature fluctuations.

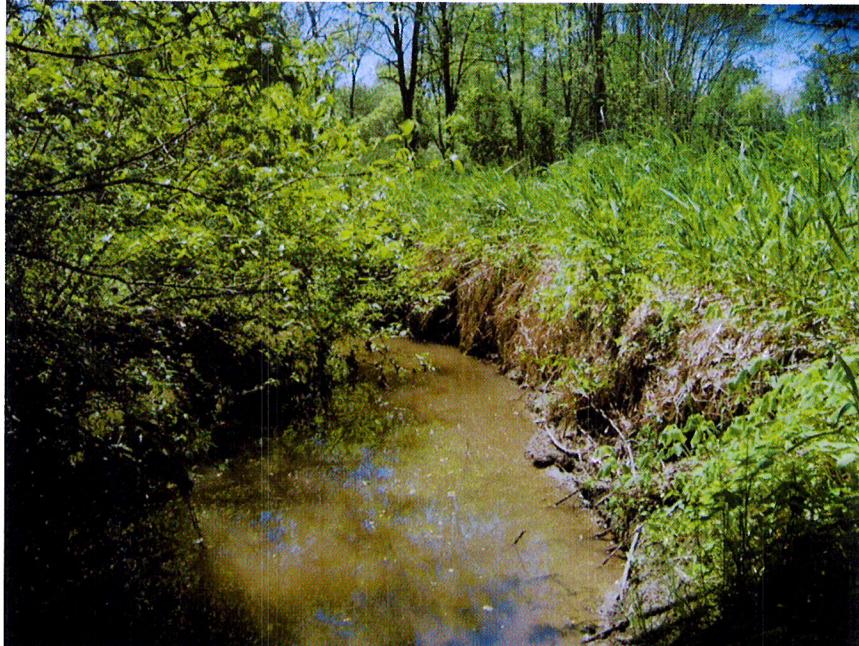
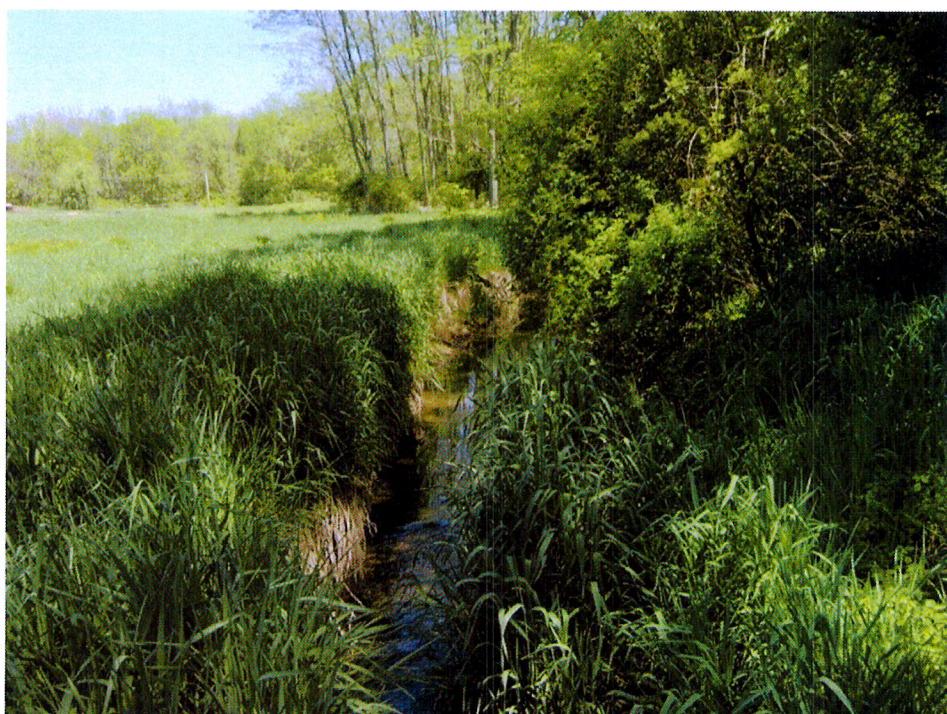
### **Impacted Stream Segment #23-25:**

Legacy sediment is prevalent throughout the floodplain within this stream reach. The streambanks throughout this area are 3 to 4 feet high and actively eroding. The riparian zone to the west of the stream is mowed to the top of the bank. In areas where trees and shrubs are located along the banks, multiflora rose dominates.

Restoration of this area should focus on reconnection of the active floodplain with the stream. The stability of the stream should be considered from a fluvial geomorphology standpoint. As the stream bottom is covered in sediment throughout much of this section, the use of instream structures to provide fish habitat should be considered. Reconnection of the floodplain and stabilization of the streambanks throughout this reach should result in measurable water quality benefits downstream.

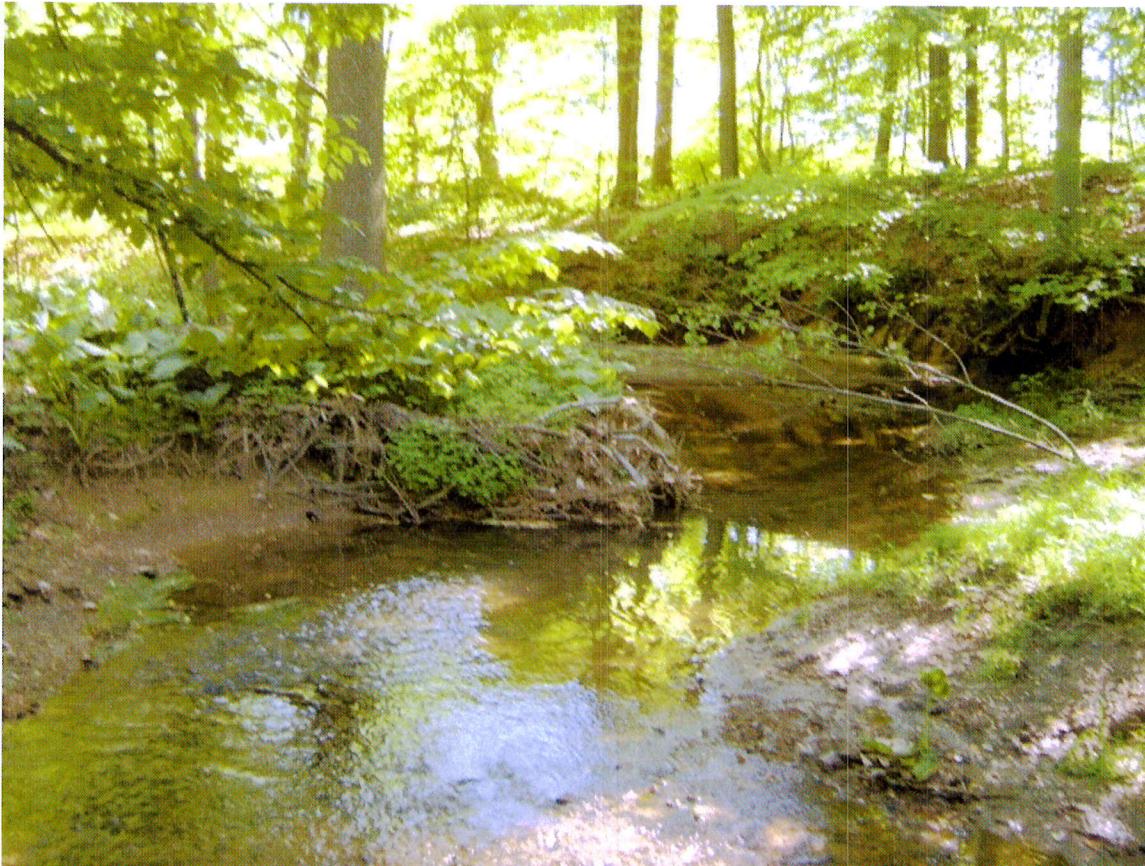
### **Impacted Stream Segment #35-36:**

Throughout this forested area, legacy sediment has accumulated throughout the floodplain. Lateral erosion of the streambanks has left raw banks that are several feet high. Bedrock is visible on the stream bottom near the upstream end of this stream segment and will limit farther down cutting of the stream.

Restoration of this stream segment would require legacy sediment removal and restoration of the floodplain. The riparian forest and wetlands that are located on top of the legacy sediment will need to be impacted and restored at historic elevations in order to achieve the greatest long-term stability in this area. Before restoration of this area is undertaken, permit review staff from the regulatory agencies should be invited to the site to discuss the project objectives and restoration requirements of the project.

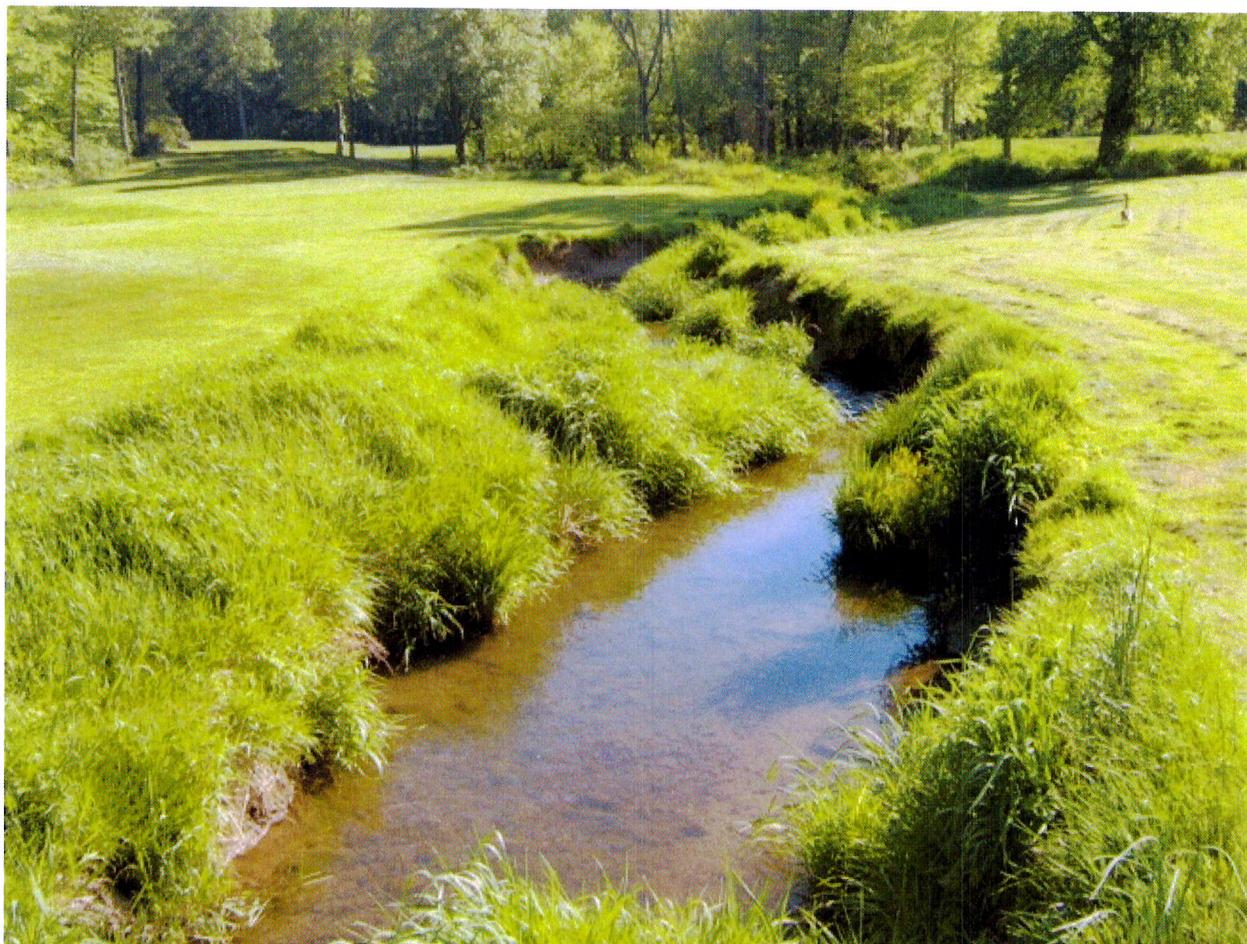
### **Impacted Stream Segment #36-37:**

This stream segment is severely impacted by legacy sediment and has several areas with raw, eroding stream banks. Invasive species dominate the areas along the stream where a riparian buffer exists. The golf course has mowed to the top of streambank throughout much of the reach.

Restoration of this stream segment is ongoing. Funding of this project is provided by a DEP Growing Greener Grant, Kennett Square Golf and Country Club, Chester County Conservation District, Dockstader Foundation, and Red Clay Valley Association. The use of natural stream design, floodplain reconnection, two acres of riparian buffer plantings, bank stabilization and one acre of wetlands improvement should greatly enhance this stream segment. Upon completion, this project will serve as a showcase demonstration project within the watershed that will be a great reference project for attaining landowner support for future projects.

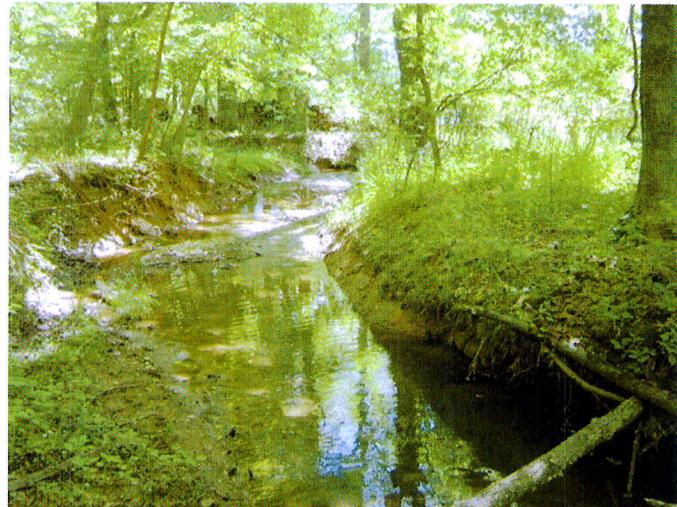
#### **Impacted Stream Segment #3-8:**

The streambanks within the forested portion of this reach are eroded and about 3 to 5 feet high. The stream channel appears overly wide and incised. As the stream flows into the open field and lawn area at the bottom of the reach, bank erosion is less of a concern, but the riparian buffer is lacking.

Balancing the impacts of floodplain restoration and streambank stabilization within this forested area will be challenging. A mix of instream structures and minimal bank restoration grading will likely be necessary to stabilize this reach. Downstream of the forested area, a native riparian buffer should be planted.

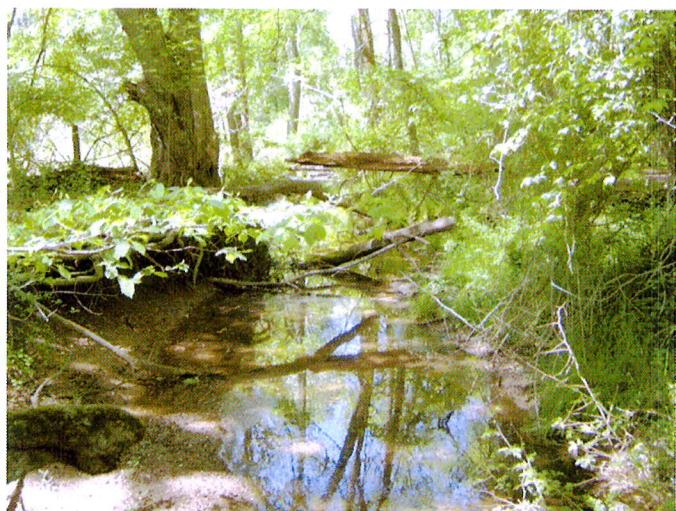
#### **Impacted Stream Segment #20-22:**

Within this stream segment, the stream channel is incised 2 to 3 feet with raw, eroded banks on both sides of the stream. Streambank erosion in this area is likely a major contributor to the impairment of stream assessment site 5 (Clauser and Clauser 2010). A mowed lawn extends to the top of the stream bank in the downstream portion of the stream segment.

Restoration of this stream segment should include streambank stabilization with a floodplain restoration component. Restoration of this reach would be challenging. Wetlands and mature forest are perched on top of legacy sediment deposits throughout the forested section. A limited streambank stabilization and buffer planting in the lower section of the reach would require substantially less resources, but would also have less of an impact downstream.

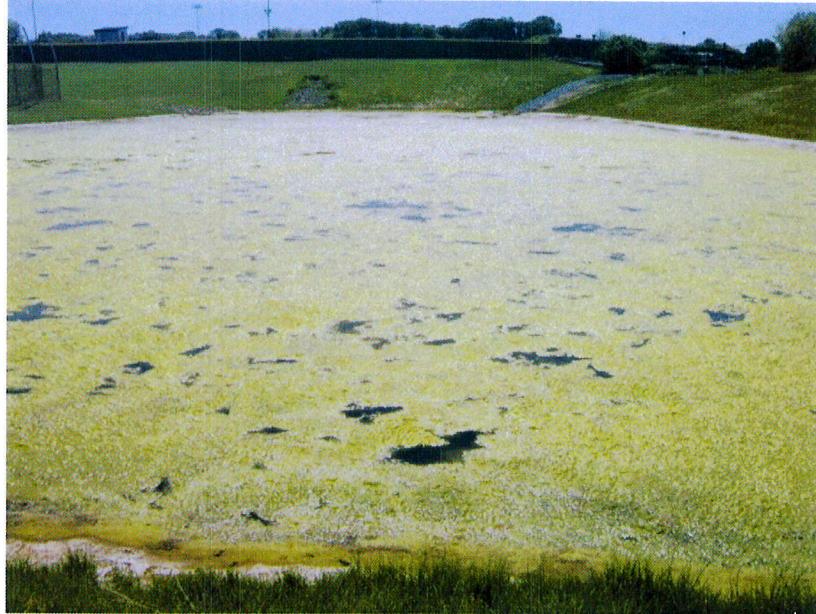
### **Impacted Stream Segment #26:**

A stormwater basin at this location is experiencing an algae bloom. Excessive nutrient inputs likely occur from the upslope playing field and lawn areas.

The landscape crew that is responsible for maintaining the playing field and lawn areas for the Unionville High School should be contacted to discuss implementing a nutrient management plan. Additionally, education and outreach within the watershed should focus on downstream impacts of over-application of lawn fertilizers.

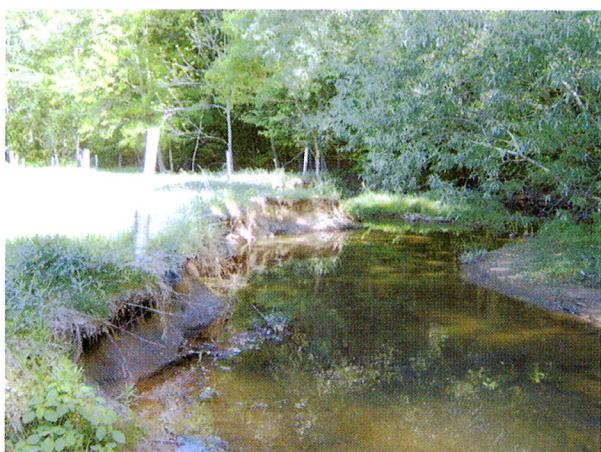
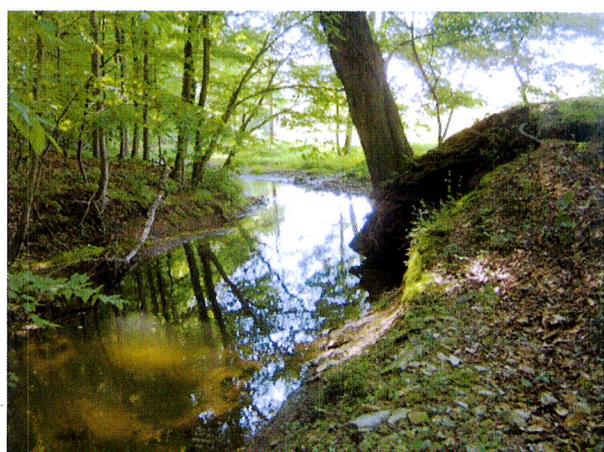
### **Impacted Stream Segment #33-34**

A small earthen dam was breached within this segment. Legacy sediment is evident on the northern streambank. The streambank is several feet high and actively eroding.

Restoration of this area should include a minor streambank stabilization project. The eroding area is just over 200 feet long. Streambank work within this area would likely qualify for general permit coverage. Wetlands do not appear to be an issue. Soils that are removed from the streambank could likely be spread over the upslope crop fields out of the floodplain.
