**Restoration Plan  
for  
Trib. 414 Watershed  
Chester County, Pennsylvania  
August 2008**

RETTEW Associates, Inc.  
Natural Sciences Group  
950 East Main Street, Suite 220  
Schuylkill Haven, PA 17972  
(570) 385-2270  
(570) 385-2217 fax  
RETTEW Project No. 07-07957-002

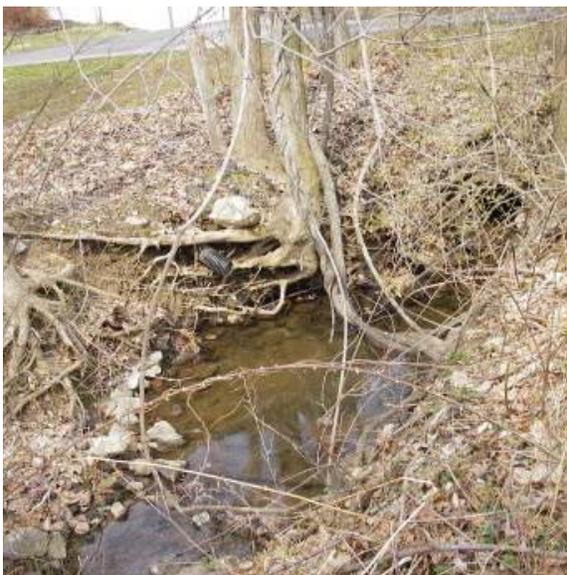
The stormwater from the extensive impervious areas upstream of this location are likely the cause of much of the downslope degradation. While the stream is not incised and indicative of an impacted stream from a habitat standpoint, the shallow bedrock is likely playing a role in stabilizing this area. While points 39 and 73 indicate the areas of the watershed where stormwater management retrofits become most necessary, this high priority project is a watershed wide initiative. The field investigation map indicates where good sites for initial stormwater best management practice retrofit projects are located (Appendix A).

Urban stormwater management retrofits that consider volume, rate, and water quality should be included with any work that drains into Trib. 414. While landowner education targeting homeowners will be helpful, an outreach program that targets the commercial areas of the watershed may have the greatest potential for success. Consideration should be given to development of a recognition program

where businesses that install stormwater retrofits receive a “Friends of the Red Clay Watershed” sign to help identify them as a watershed steward to their patrons and employees. Educational programs in this community should focus on reducing the discharge of stormwater to Trib. 414. Stormwater retrofits including extended detention ponds, wet ponds, constructed wetlands, bioretention areas, filtering practices, infiltration practices (including drywells, infiltration trenches, permeable pavers, etc.), vegetated swales, green roofs, stormwater planters, rain gardens, rain barrels and stormwater cisterns should be encouraged (Shueler *et al* 2007).
